CAISSON MANAGEMENT

Date: April 2024
Location: Offshore North Sea Asset
HSEQ Statistics: Zero incidents

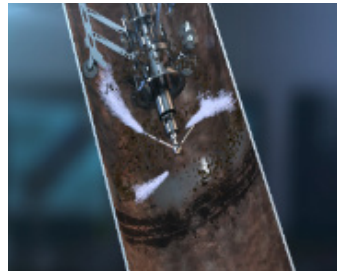
Photo: Cleaning

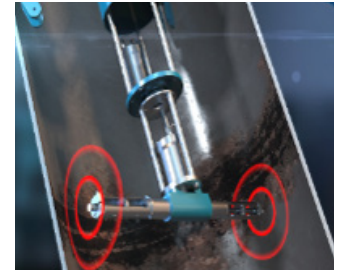
Photo: Inspection
