DRONE INSPECTION

Project: TSR leak identification and remediation

Client: Major Netherlands operator

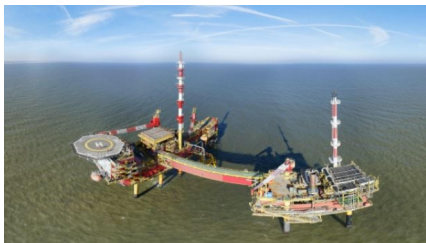
The client identified that the underside of the living quarters (LQ), which is also the temporary safe refuge (TSR), was leaking air when pressurized but the exact location of the leak was unknown.

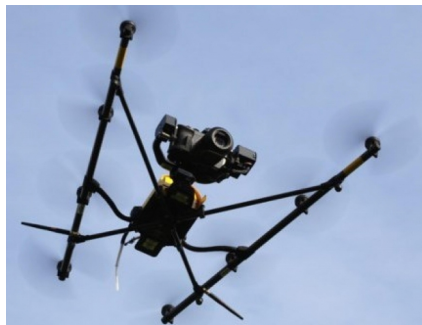
Stork analyzed the situation and recommended to first use a drone to carry out the underside inspection. This was very successful as the leak location was identified within minutes. Subsequently only a very small section of scaffolding was needed to get reach the leak and repair it.
