COMPOSITE REPAIR HELIDECK WALKWAY

Project Information:

- **When:**
August 2013
- **Location:**
North Sea platform
- **Workscope:**
Delivering a composite repair solution for a helideck walkway damaged by a water leak
- **Installation:**
Stork PowerSleeve
- **Materials:**
PowerSleeve and Bio-Dur 563
- **Safety:**
Project delivered without an LTI

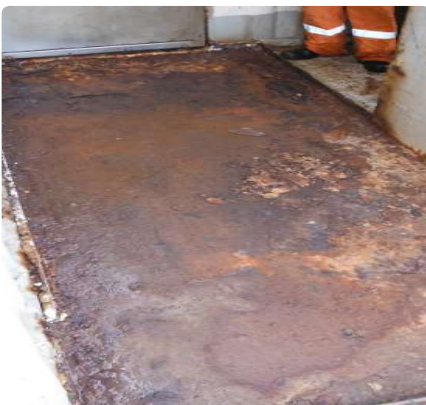
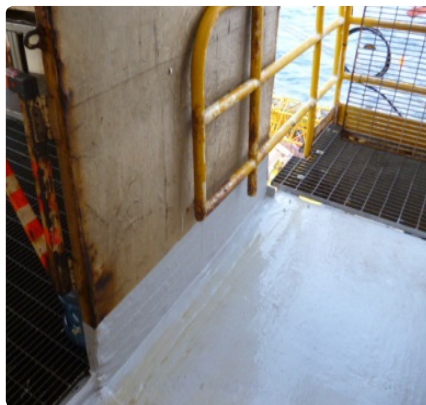
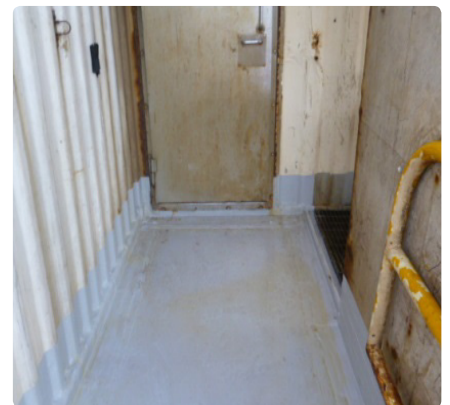
A water leak was identified in the accommodation module of an offshore platform in the UKCS. The leak was affecting the integrity of the helideck walkway and required repair.

The source of the leak was found to be in the roof above the Smokers' Lounge.

Stork's Composite Repair team proposed to apply PowerSleeve around the circumference of the walls and Bio-Dur 563 to the remaining exposed steelwork on the floor.

At the platform's request, PowerSleeve was applied to both the walls and the floor. A cosmetic paint coating was then applied to the platform's specification.
