RUPTURED WATER OVERFLOW LINE

- **When:**
February 2015
- **Location:**
North Sea Platform
- **Workscope:**
Temporary Repair to a ruptured water overflow line
- **Installation:**
Field Wetted Power Sleeve and AquaWrap
- **Materials:**
BioDur 563 , 5/20 Epoxy Putty, PowerSleeve & AquaWrap
- **Safety:**
Project delivered without incident

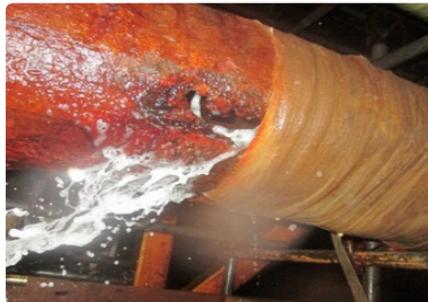
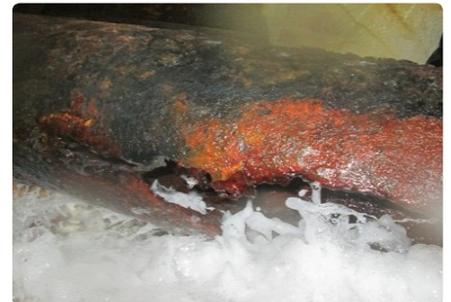
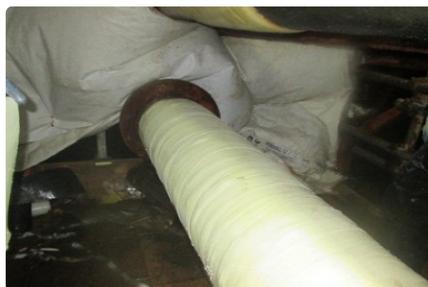
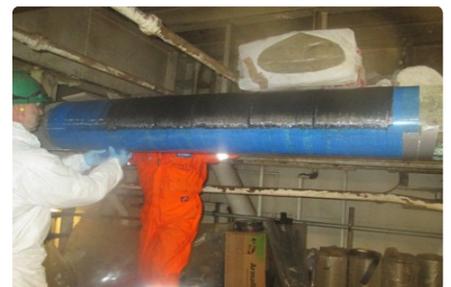
A temporary repair on the 12" overflow drain line had deteriorated to the extent that the bottom section of the existing pipework had eroded away, resulting in a rupture which was releasing a continuous flow of water. Stork's composite repair team were asked to review the operating parameters and challenged to provide a solution which would enable the repair of the pipework temporarily and restrict the leak to an acceptable level until a replacement spool could be fabricated.

Stork designed a Composite Repair solution using PowerSleeve, AquaWrap, BioDur563 and Epoxy Putty and, by utilising previously trained platform personnel, it was able to react quickly.

PowerSleeve was used first to prepare half-shells 1.4m in length, cast from the existing pipework.

Preparation, normally completed by blasting to SA2 ½, was not feasible in the immediate area where heavy corrosion was visible. Therefore, to reduce the preparation requirement, the area was primed with BioDur 563 which acted as a primer and load film transfer material.

Where there was heavy pitting 5/20 Epoxy Putty was used to reinstate the pipe profile. Once cured, four layers of AquaWrap was applied to put structural strength back into the pipework.
