HOT BOLT CLAMP ROPE ACCESS

Project: Corroded bolt removal and replacement

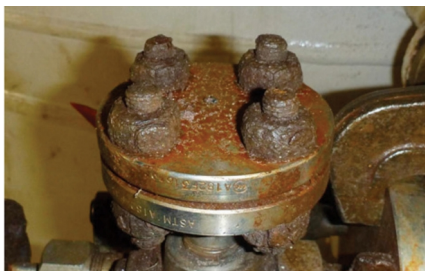
The Client had corroded studbolts on four-bolt flanges in its offshore oil and gas platform in the Gulf of Mexico.

This posed a potentially significant safety issue and Stork was tasked with removing and replacing the bolts on 300 flanges during a planned turnaround.

Stork utilized its patented Hot Bolt Clamp (HBC) technique and rope access solutions to safely and efficiently remove and replace the corroded bolts on the identified flanges

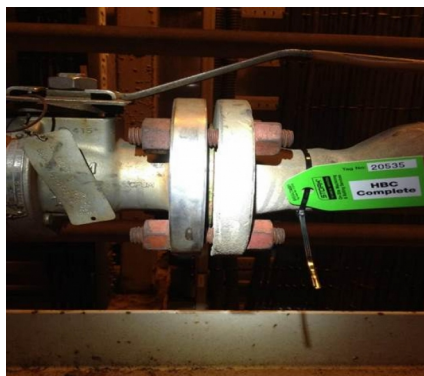
During the campaign, the Stork Hot Bolt Clamp team found a leaking flange. After thorough risk assessments and with the inclusion of additional PPE, Stork replaced the bolts on the flange and prevented further leakage.
