SPECIALIST CLEANING

Location: Offshore Asset, Irish Sea

SCOPE OF WORK

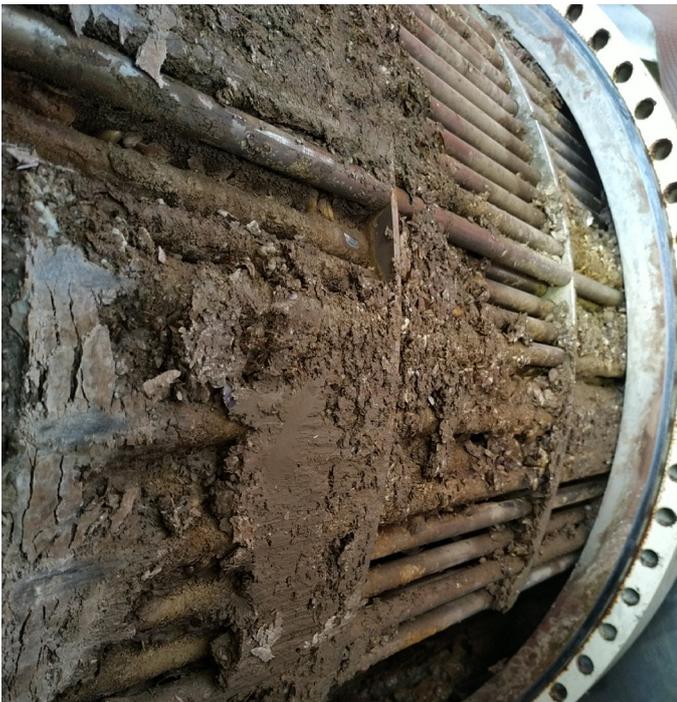
Upon investigation of the tube bundles, it was noted the external shell was clogged with solidified scales and the tubes had partial blockages due to wax and scale build up, which ultimately led to an impact on production.

Photo: Before cleaning

Conventional retro-jetting didn't provide the desired end result. Therefore, Stork's team of experts re-assessed the scope and altered the methodology to tackle the challenge. This ultimately ensured our client's expectations were met. The deployment of a specialist pencil jetting unit was utilised to remove the hard scales. Also the use of a BJV centraliser was used to protect the tool as it passed through the pipe and balanced the jet stand-off distance for a more consistent clean.

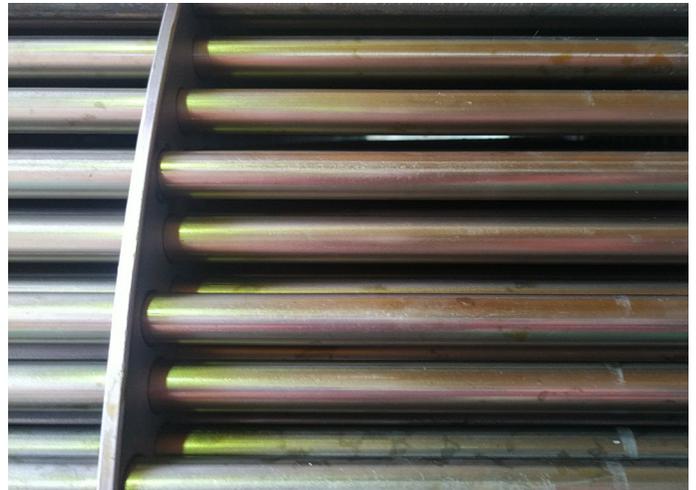
Photo: After cleaning

A 9-man multi-disciplined team mobilised at various times throughout the scope, working a range of day / night shifts. Through use of bespoke jetting techniques, the team cleared the tube bundles and shell of scale and debris to allow for an Internal Rotary Inspection System (IRIS) inspection to take place. This advanced ultrasonic non-destructive testing (NDT) technique is used specifically to inspect pipes and tubes.

- Before starting the job, all worksites were safely set up with bunds, which were erected to contain all liquid and debris
- All Stork personnel were suitably qualified, along with certified plant and equipment to carry out the scope of work without delay
- Work was carried out with a safety-first approach and as a result, no accidents, incidents or injuries occurred
- The six heat exchangers were cleaned to the client's satisfaction and back up to full working capacity
