SPECIALIST CLEANING

Location: Offshore Asset, Irish Sea

Stork was contracted by a major UK-based operator to complete specialist cleaning works on six heat exchangers which were operating at reduced capacity on an offshore asset in the Irish Sea.

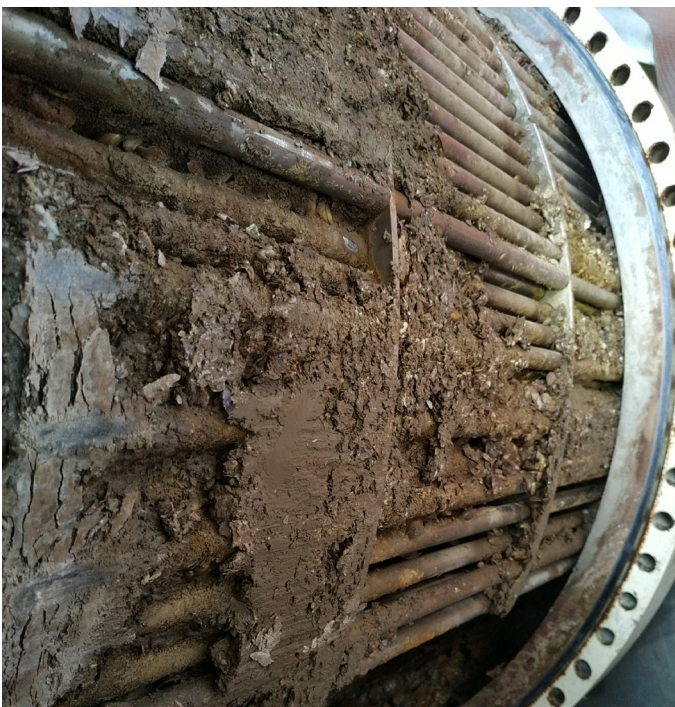
Upon investigation of the tube bundles, it was noted the external shell was clogged with solidified scales and the tubes had partial blockages due to wax and scale build up, which ultimately led to an impact on production.

Photo: Before cleaning

Conventional retro-jetting didn't provide the desired end result. Therefore, Stork's team of experts re-assessed the scope and altered the methodology to tackle the challenge. This ultimately ensured our client's expectations were met. The deployment of specially selected jets were utilised to remove the hard scale. A jet centraliser was used to protect the jet as it passed through the vessel internal shell, centralising the jet extension arms to a stand-off distance for a more consistent clean.

A 3-man multi-discipline team was mobilised to execute this scope of work. Through use of bespoke jetting techniques, the team cleared the tube bundles and shell of scale and debris to allow for an Internal Rotary Inspection System (IRIS) inspection to take place.

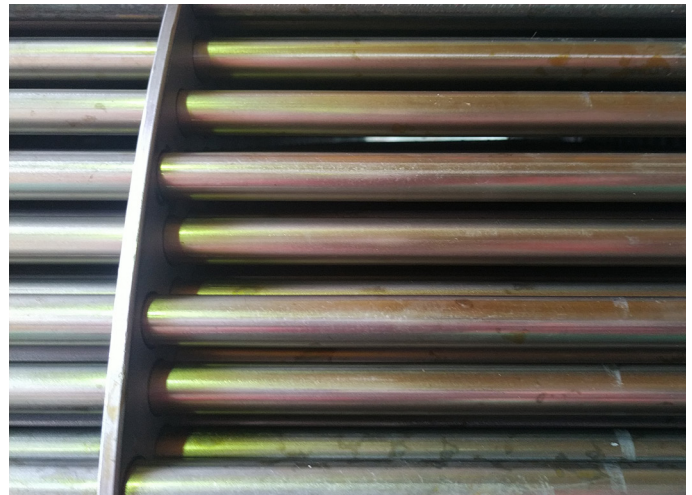
Photo: After cleaning

- Before starting the job, all worksites were safely set up with bunds, which were erected to contain all liquid and debris
- All Stork personnel were suitably qualified, along with certified plant and equipment to carry out the scope of work without delay
- Work was carried out with a safety-first approach and as a result, no accidents, incidents or injuries occurred
- The six heat exchangers were cleaned to the client's satisfaction and back up to full working capacity
