# LASER CLADDING TURBINE REPAIR

**Project:** Turbine casing repair

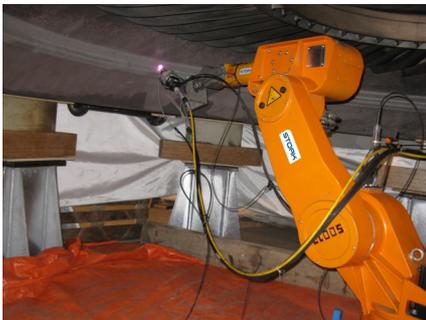
The client identified severe erosion damage on the inner casing of a low pressure steam turbine. The impact of small water droplets, which develop during the operation of a turbine, had caused the wall thickness to deteriorate to an extent that it was unsafe to operate.

Laser cladding applies a hard facing, wear resistant layer to repair, prevent further damage and extend an asset's lifetime for years to come.

Stork's laser cladding team deployed the innovative technology and performed the repair onsite on a 24/7 basis. After three weeks of non-stop activity, four large sections of the casing were repaired and the installation was taken back into operation shortly after.

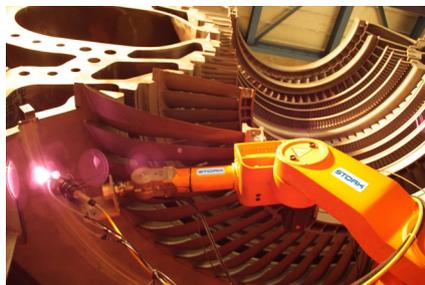
An end-of-warranty inspection was conducted after three years and the new layer was in good condition. Due to the high wear resistance of the new layer, no new damage had occurred.
