# POWERSLEEVE EXTERNAL CLADDING

Stork was contracted by Wood Group PSN to reinforce the structural integrity of a two level module after severe corrosion was identified on Shell U.K.'s Brent Alpha installation. All four sides of the module showed severe corrosion and multiple through wall anomalies.

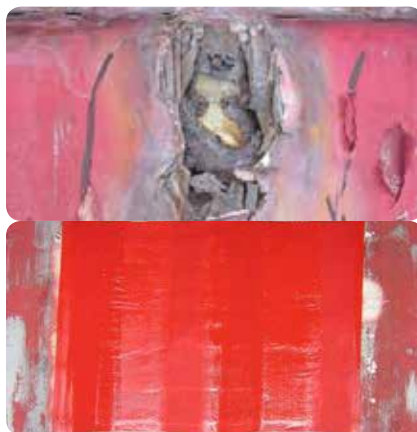
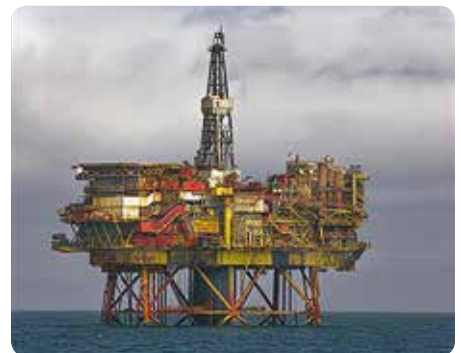
The surface of the module was hand prepared by Stork's multi-skilled rope access technicians and all voids filled with epoxy putty to smooth the surface area. All repair calculations are conducted in-house, providing the client with a fully customised rapid delivery.

Stork's technicians were able to completely cover affected area; restoring original structural integrity.
