HOT BOLT CLAMP ROPE ACCESS

Project: Removal and replacement of corroded bolts on fire water ring main

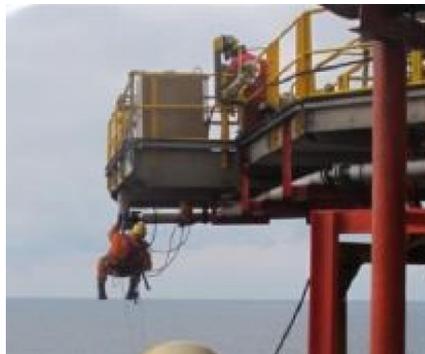
The Client identified corroded bolts on 29 four-bolt flanges on the fire water ring main of its floating production platform.

The bolting was in poor condition due to the salt water atmosphere which caused severe corrosion of unprotected carbon steel components. The height and position of the flanges meant that scaffolding could not be easily constructed for access.

Stork's innovative Hot Bolt Clamp (HBC) technique and rope access solutions allowed the corroded bolts to be removed and replaced without disruption to the safety system.

The project was staggered to allow the HBC team to manage the deck level flanges first, then the rope access team mobilised to work on the difficult to reach flanges.
