# POWERSLEEVE DRAIN SPOOL ELBOW

Stork was contracted to repair the perforation on a 4" closed drain spool elbow located on Nexen's Scott installation.

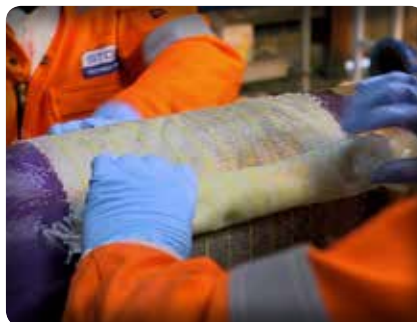
Stork's technicians were able to completely cover affected area; strengthening structural integrity.

The surface of the 4" closed drain spool elbow was hand prepared by Stork's multi-skilled technicians. All voids were then filled with epoxy putty to smooth the surface area.

Stork's innovative pipe repair solution; PowerSleeve was then utilised.

PowerSleeve's engineered composite reinforcement was selected because of its 100% solids epoxy impermeable barrier. This combined with the strength of its custom E-glass and Kevlar® fabric made it the best choice to encapsulate and reinforce the entire spool elbow.
